# Mechanic Fatally Injured by Split Tire Rim

**Source:** Alaska Fatality Assessment and Control Evaluation (FACE) Program, Case Report 0SAK006

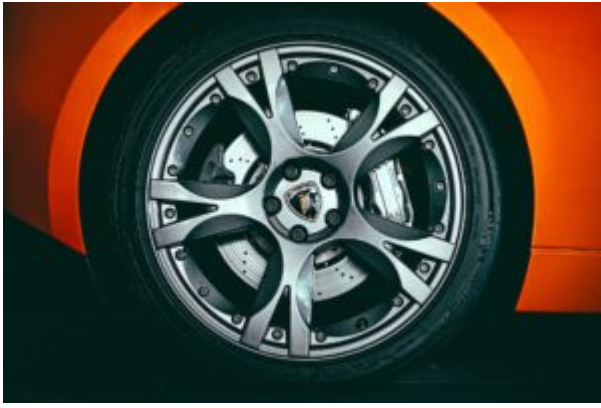
A 26-year-old mechanic was struck and killed by a side ring from a multi-piece (split) tire rim.

The investigation revealed that the rim parts were heavily pitted by corrosion, obscuring the stamping marks. This corrosion indicated that they were not cleaned and inspected prior to replacement. In addition, the locking ring was deformed. These items contributed to the incident.

*Recommendations included a warning to clean and inspect all rim parts after removal and prior to remounting. Properly matching parts before mounting them, and posting OSHA charts for rim matching, and rim removal and remounting are also important. In addition, workers should be trained on the procedures for removal and mounting of tire rims. Finally, manufacturers should clearly label rim parts to encourage inspection and matching of parts prior to use.*
