# Painter Electrocuted by Fluorescent Light

A 49-year-old man was electrocuted when he leaned on a fluorescent light fixture while painting.

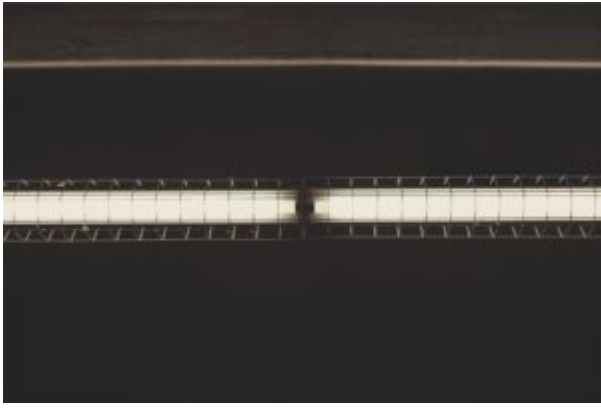
The victim was painting steel “I” beams located about 12 feet (3.7 meters) above the floor. Numerous pipes, conduits and 110-volt light fixtures were in the area. In order to reach the beam, the victim was standing on a ladder, leaning across a conduit and one of the light fixtures. He died after electrical current traveled from the energized housing through the victim’s chest and out through the victim’s right arm, which was in contact with pipes and conduits connected to the ground.

*To stay safe, workers must learn the basics of electrical energy. Leaning on the fixture put stress on it, causing the wires ? which were not properly secured or protected where they entered the fixture—to contact the housing. The victim also created the potential for electrocution by providing a “path to ground” by contacting the fixture and the overhead pipes. It was made worse since it was very hot and the man was sweating, increasing the effect of the current. This tragedy could have been prevented. Be aware of and report hazards where you work.*
