# Upper Boom Failure on Aerial Lift

## Incident Summary

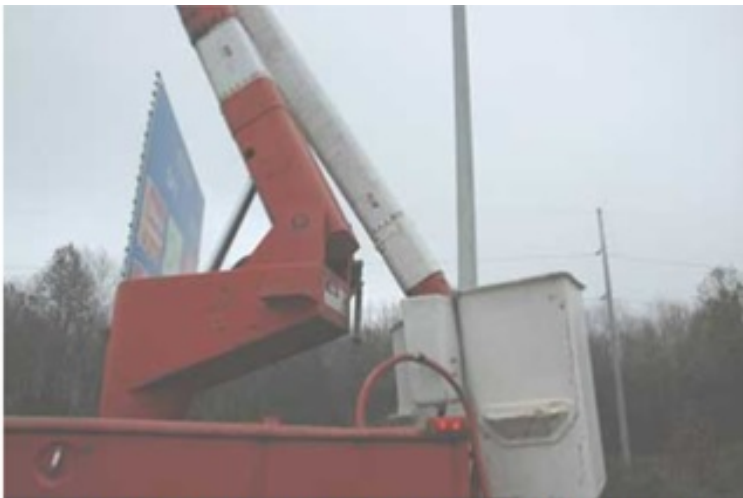
A 45-year-old owner of an electrical contracting company died after falling 9 feet to the road when the articulating boom of the aerial lift truck he was working from collapsed (photo 1).

Photo 1: Aerial lift boom after incident. Note that the lower boom section remains elevated while the bucket-end of upper section is in a lowered position (photo courtesy of OSHA).

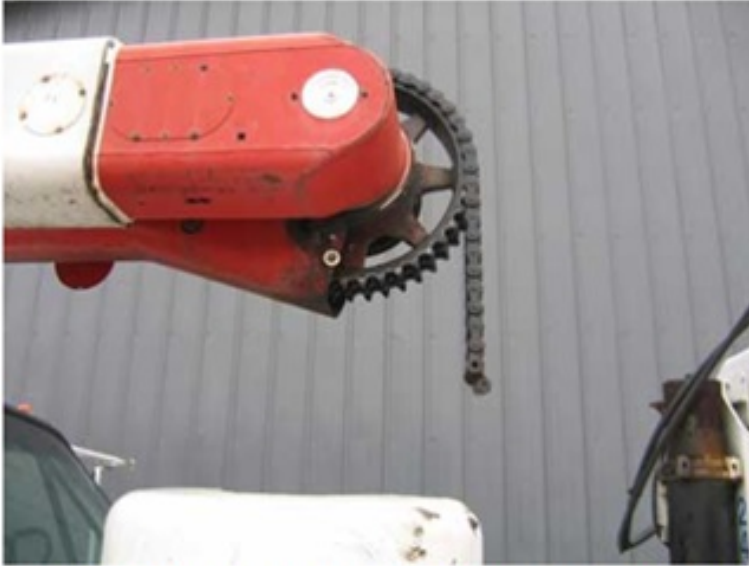
Post incident inspection of the articulating boom revealed the boom actuating chain had separated resulting in the catastrophic collapse of the upper boom (photo 2).

Photo 2: Broken boom actuating chain (photo courtesy of OSHA).

It appears lack of proper lubrication of the chain is likely what caused the chain to break. This incident highlights the significance of:

1. Reading and adhering to the manufacturers’ recommended maintenance schedule. The operation and maintenance manual detailed maintenance recommendations, procedures and warnings.

- In particular, the manufacturer recommended the roller chains, including the upper boom actuating chain, be lubricated every 30 days.
- A warning in the manual stated a lack of lubrication can cause galling and corrosion of the chain pins; breakage of the pins; and result in free fall of the upper boom (photo 4).

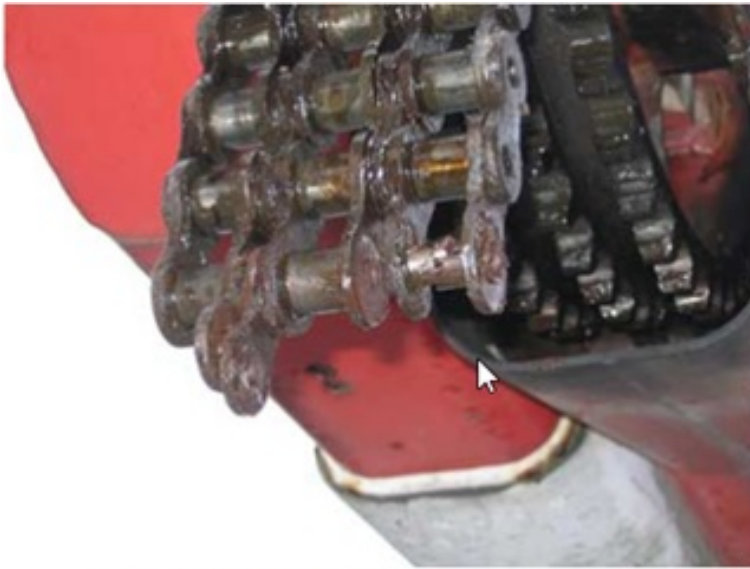
Photo 4: Broken section of boom actuating chain  
(photo courtesy of OSHA).

2. Pre-use inspection and removing suspect equipment from service until has been made safe to use.
3. Regular maintenance and inspection by a qualified person.
  - The operation and maintenance manual recommended regular maintenance and inspections to include – the upper boom actuating chain for lack of lubrication, broken rollers and pins.
  - It also stated lack of lubrication is indicated by squeaking or groaning noises when the booms are moved.
  - The recommended inspection/maintenance frequency for pulleys, sprockets, pins and chains is monthly. A major overhaul of the unit was recommended, according to average use, after 3 years or 6,000 hours of use, whichever came first
    - The aerial lift involved in this incident was 18 years old.
    - There was no record of maintenance and inspection having been performed on the boom structure or other assemblies of the aerial lift.
