# Fatalities in the Oil and Gas Industry

## Crew stays clear of runaway spool

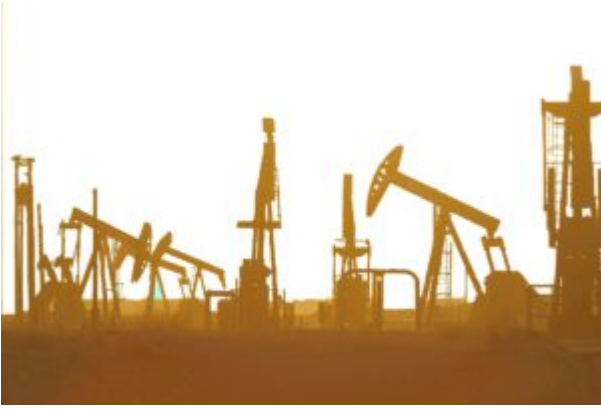
A drill crew was in the process of slipping and cutting a 1-3/8 drill line. Two floormen were assigned to un-spool wire rope until there was approximately a 40-foot loop below the storage reel.

As the drill line reached the desired slack, the spool continued to rotate due to its momentum. An attempt was made to stop the rotation by using a wooden board as a brake lever.
