# Electric Tools – Grounds for Concern

## Fatality Report

### Hand injury from portable handheld Angle Grinder

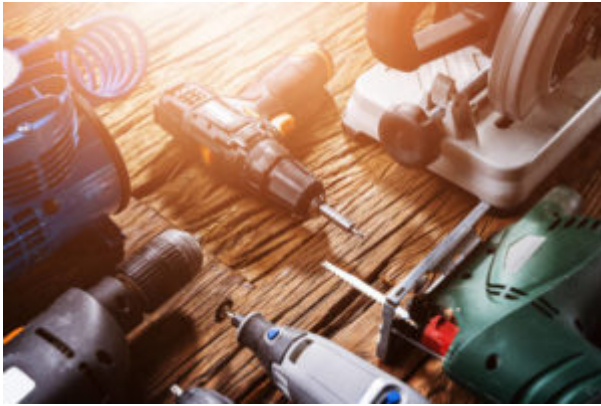
A worker was injured whilst cleaning equipment using a portable handheld angle grinder fitted with a wire brush. The rotating brush caught an edge and kicked into the worker's gloved left hand. The glove was pulled into the rotating wire brush resulting in a deep abrasion to the hand.

- The task risk assessment was incomplete.
- The grinder was being used without the side grip handle fitted;
- No consideration was given to where to place the hand relative to the rotating brush;
- Given the operator's position, the grinder could not be used safely. The operator should have moved to the other side of the component to complete the task, and deployed the grinder in a horizontal position;
- There was no formal power tool / abrasive wheel training in place;
- There was inadequate supervision of the task.

- Task risk assessment amended to include all hazards and control measures;
- Angle grinder side grip handle obtained and fitted, and its use made mandatory as company policy;
- Review of power tool/abrasive wheels training and competency evaluation requirements;
- Supervisors' responsibilities discussed and reaffirmed.
