# Engine Hood Crushes Worker

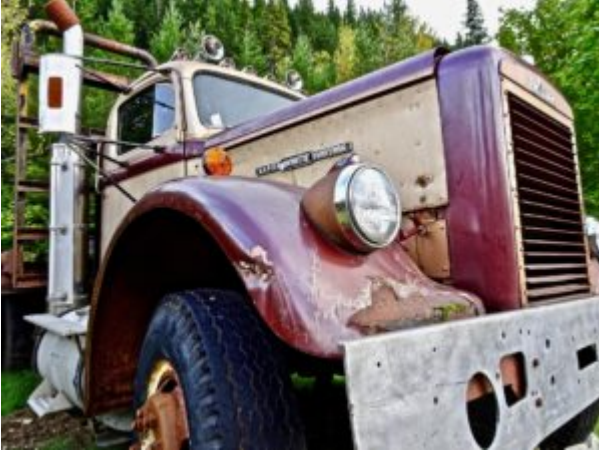
A maintenance worker was repairing a piece of heavy construction equipment when he was crushed to death by the engine hood.

It is not known why the hood fell, but it appeared to have had broken hinges and defective shock absorbers. These defects had been reported earlier but had not been repaired. There were also strong winds at the time of the incident.

*This fatality report reinforces the need for a number of safety precautions. Effective communications and safe work procedures requiring the worker to check in periodically would have been appropriate. Overhead loads must be properly blocked before working under them. Equipment should be regularly inspected. Defects such as the broken hood supports should be documented and repairs should be done before the equipment is used again. Emergency numbers and the location of the worksite should be posted so emergency responders can be directed to the site.*
