# Wedge Of Rock Falls Into Tunnel

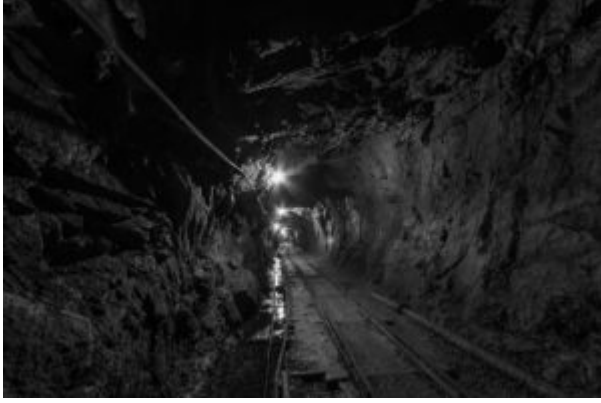
Three workers were crushed by a rockfall in a mine tunnel, resulting in one death. The fatality occurred when the experienced mine crew was working near the site of a previous incident caused by a rockfall. There was a large crack in the rock. Concern about partial collapse of the sides of the tunnel resulted in a meeting between the foreman and a rock specialist. They had noted a smaller crack was forming a wedge-shaped rock which could fall.

The crew was advised of the situation and was to continue their work of securing the tunnel by installing rock bolts. One of the crew went to obtain some longer rock bolts. The other three workers were under the rock wedge when it came down.

Two survived the crushing injuries but the third worker died.

*If this crew had adhered to the usual principle of working only under supported rock, this fatality could have been avoided. Better training and education of workers about hazards will help prevent these types of incidents. Improved communication about safety techniques will help workers become aware of the hazards as well as the safeguards for working safely.*
