# Worker Knocked Through Roof Opening

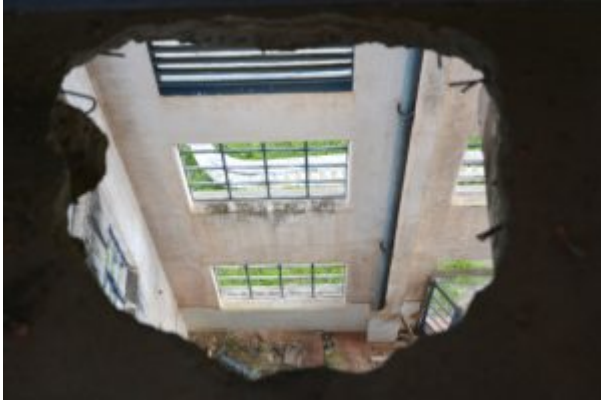
A sheet metal mechanic died after he was knocked through a roof opening and fell to a concrete floor below.

He was working for a plumbing and heating contractor that had been in business for 22 years. The victim was working on a job to fabricate and install a sheet metal cap over an opening on the flat roof of a manufacturing plant. The hole was made when an air conditioning unit was removed.

The cap, made of sheet metal, was positioned near the hole where it was going to be installed. The victim was applying caulk to a raised curb bordering the opening. A gust of wind knocked the cap over. It struck him and knocked him through the roof opening to the floor 22 feet (6.7 meters) below.

*This fatality is a reminder about the importance of planning a job safely and using the correct personal protective equipment. The placement of the metal cap should have taken into account the possibility that it would be moved by the wind. The worker should have been protected by fall arrest equipment.*
